Beechwood Lane Howe Truss Bridge, Te Marua, Upper Hutt

Heritage Report

Prepared For Upper Hutt City Council

July 2020

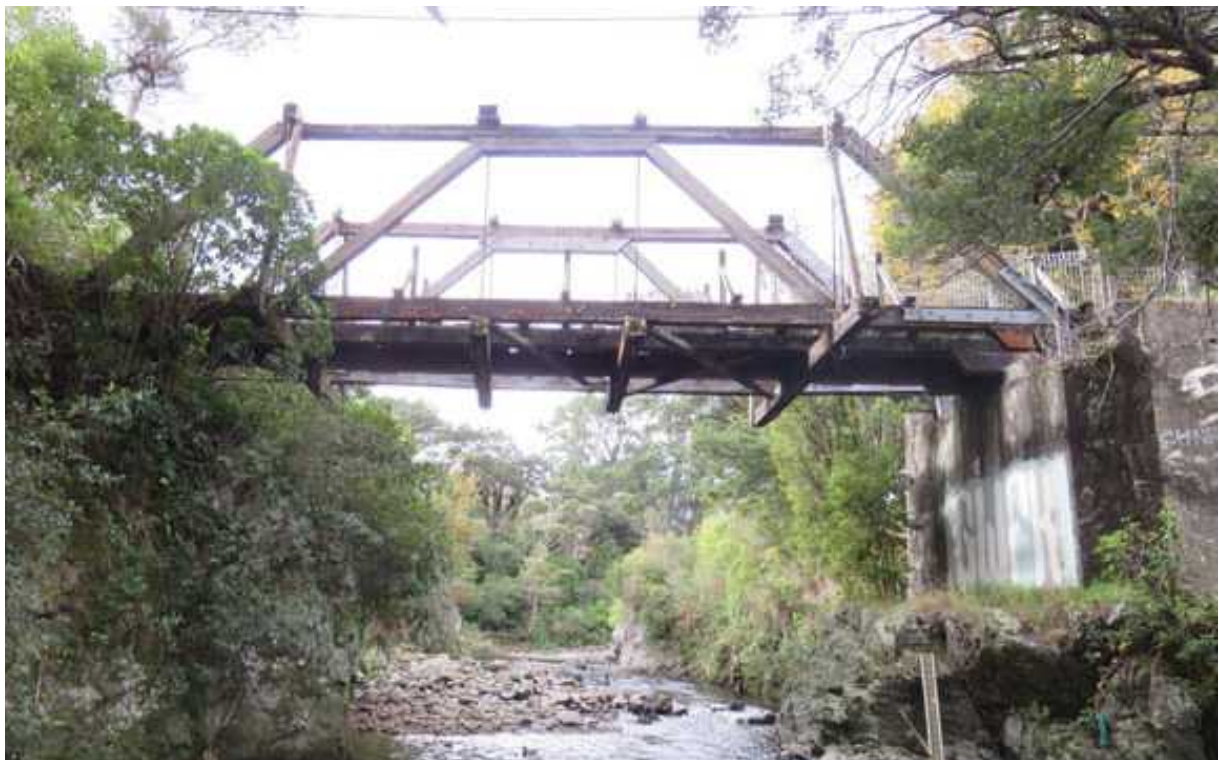
Illustration 20: Basic bridge structure (22nd May 2020).

The deck is supported by two additional stringer beams that run parallel to the bottom chords. The bottom chords and stringers are all supported by a series of 6 floor beams, two longer than the others (see Illustration 38). There were originally four (now three) reinforcing struts or buttresses attached from the ends of these beams to the ends of the top chords. It was not possible to safely sample the reinforcing struts, but it is likely that they were a native timber rather than the exotic hardwood used on the main frame. The decking timbers originally ran from base chord to base chord and it was 3.2m wide. It has presently been reduced to running from stringer to stringer and is 1.8m wide (see Illustration 38). A sample of deck timber was identified by Wallace as beech, a native hardwood (*Nothofagus* sp.-see Appendix 2) which suggests that the timbers are original or at least were replaced before the widespread use of tanalised pine. Beech is locally available in the Wellington region.

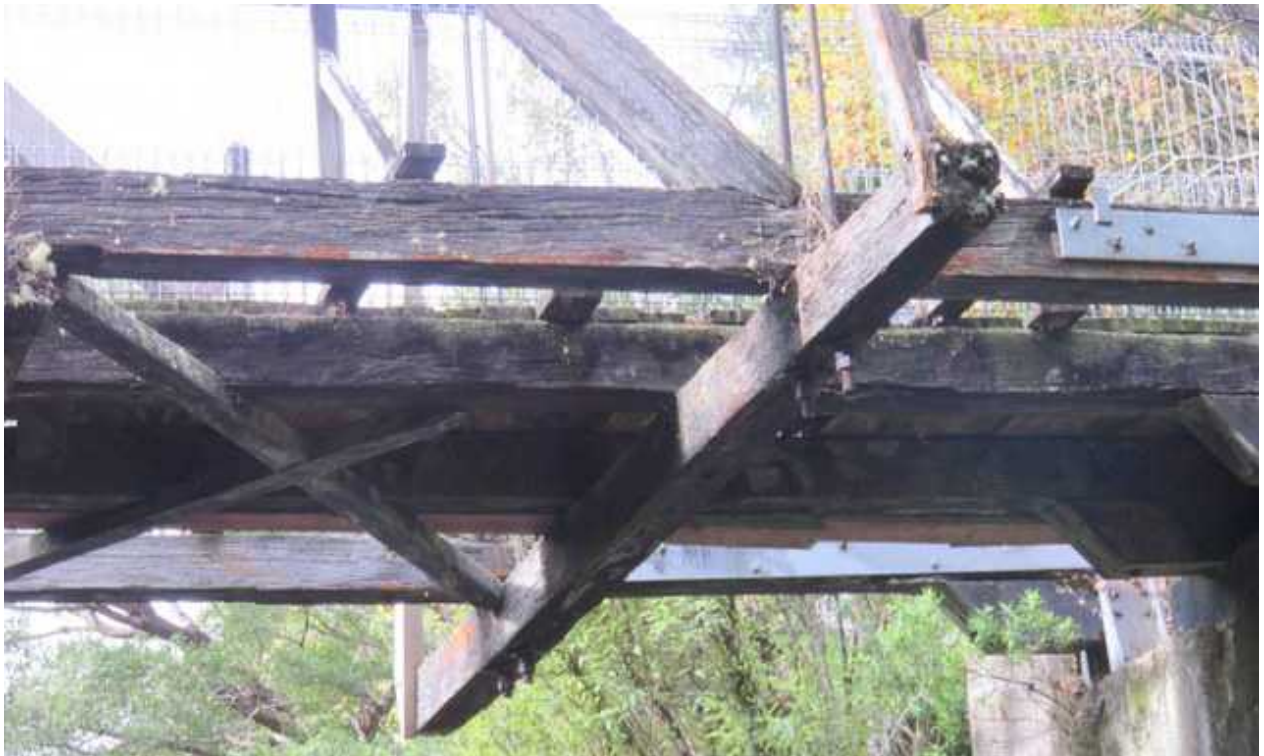
Illustration 21: Underlying deck structure (22nd May 2020).

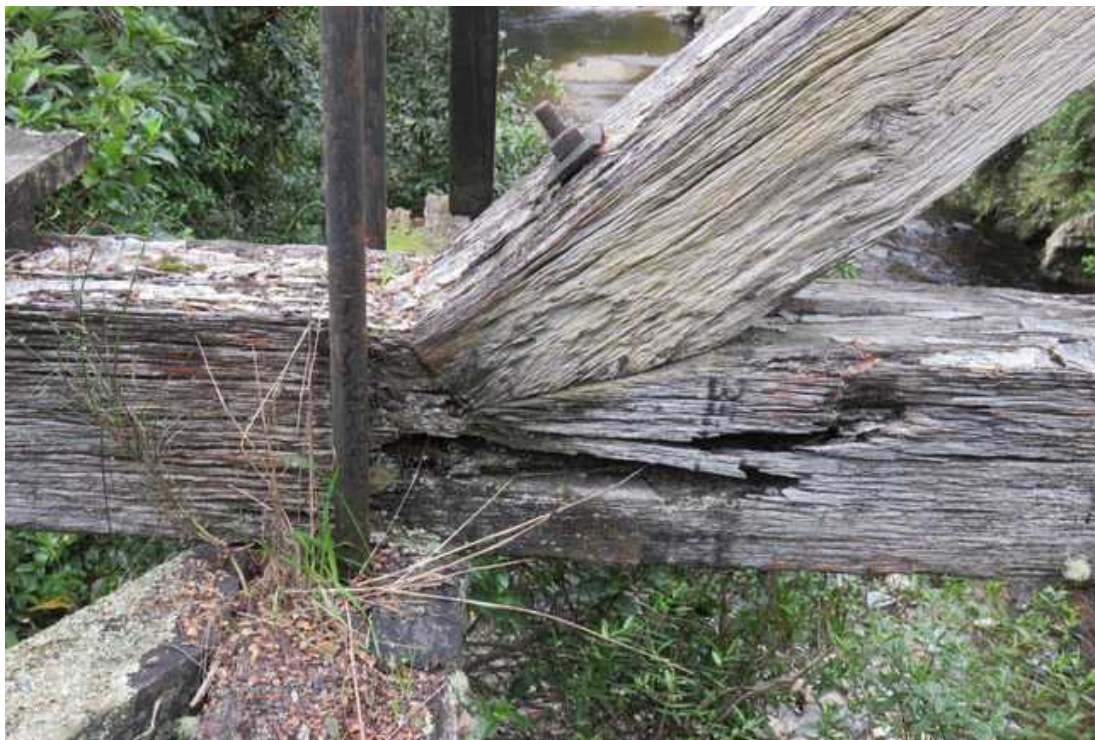
Illustration 22: End post heel joint into bottom chord (north-west end- 22nd May 2020).

The diagonal struts and end post have all been set into the bottom chord beam by means of recessed heel joints (see Illustration 22). Most other joints were simple end butt joints generally cut to a square end or 45-60 degree angle (see Illustration 23). Other joints were flush with one timber simply laid on top of another and nailed or bolted on.

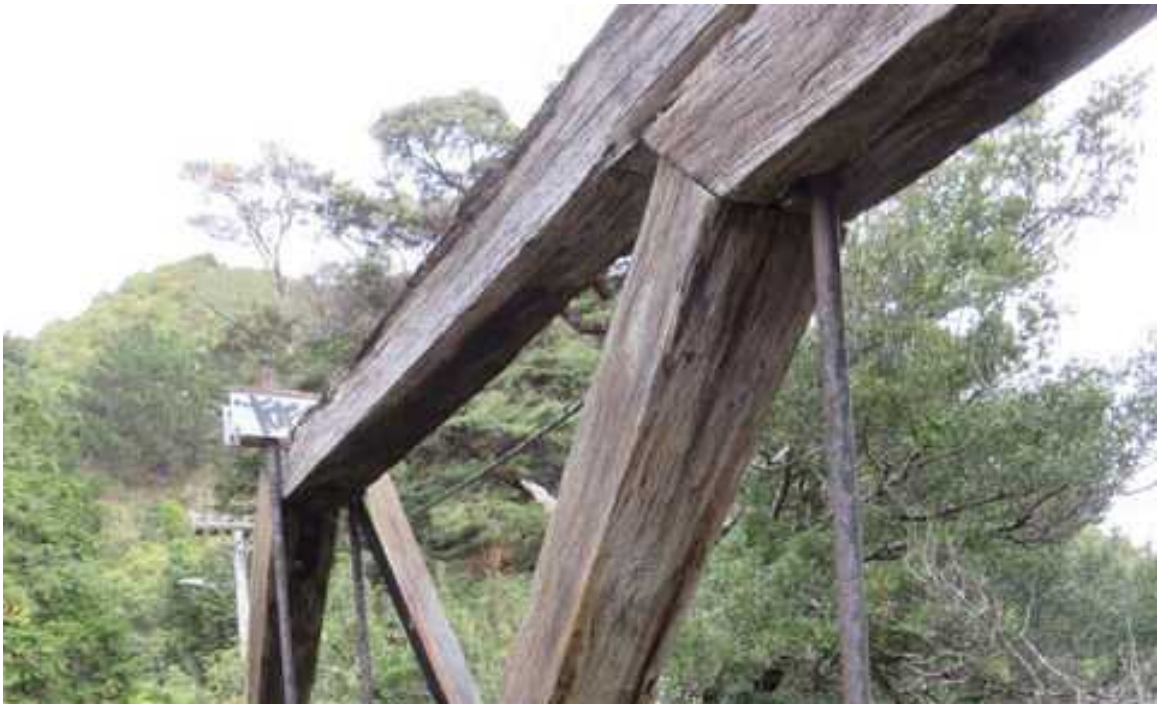
Illustration 23: Butt joint between transom and diagonal strut (22nd May 2020).

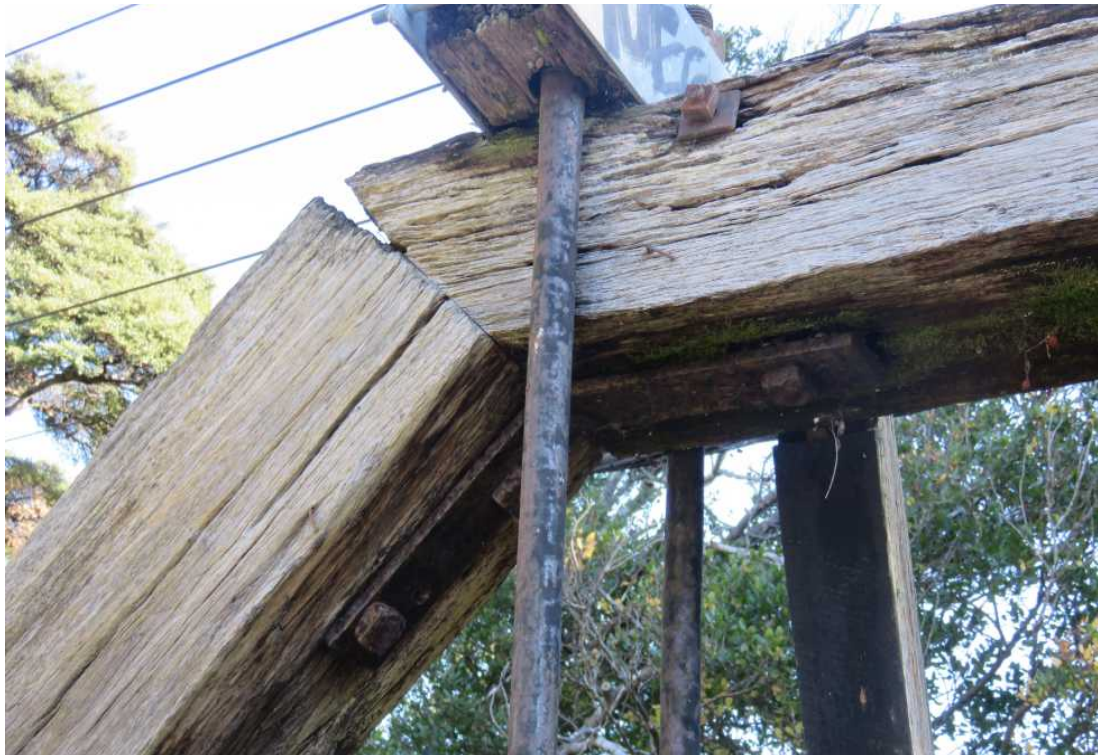
Illustration 24: Iron reinforcing plate underneath top chord and end post joint (9th June 2020).

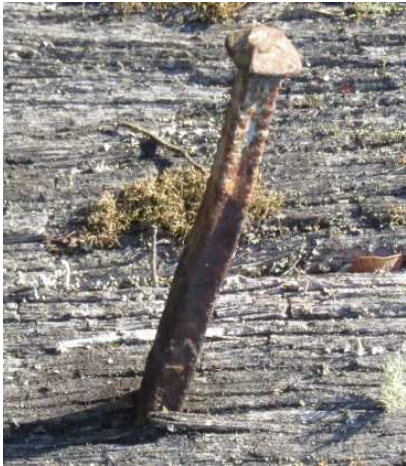
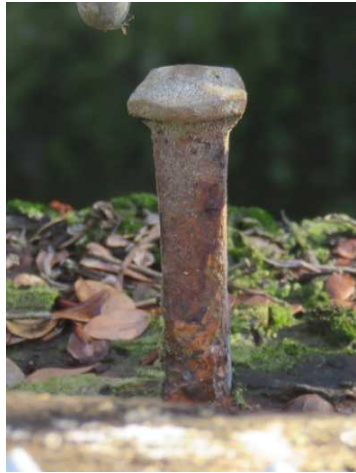
Illustration 25: Sample forged, square-shanked, rose head iron nails (in stringer) and square-headed bolt (in end post bracket) (9th June 2020).

All the beams were bolted or nailed together with iron bolts or driven iron spikes and forged nails (see Illustration 25). The top chords and end post joints were all also reinforced and secured by iron plates on the underside (see Illustration 24). The buttresses were rebated at the base secured to the floor beam ends with bolts (see Illustration 26).

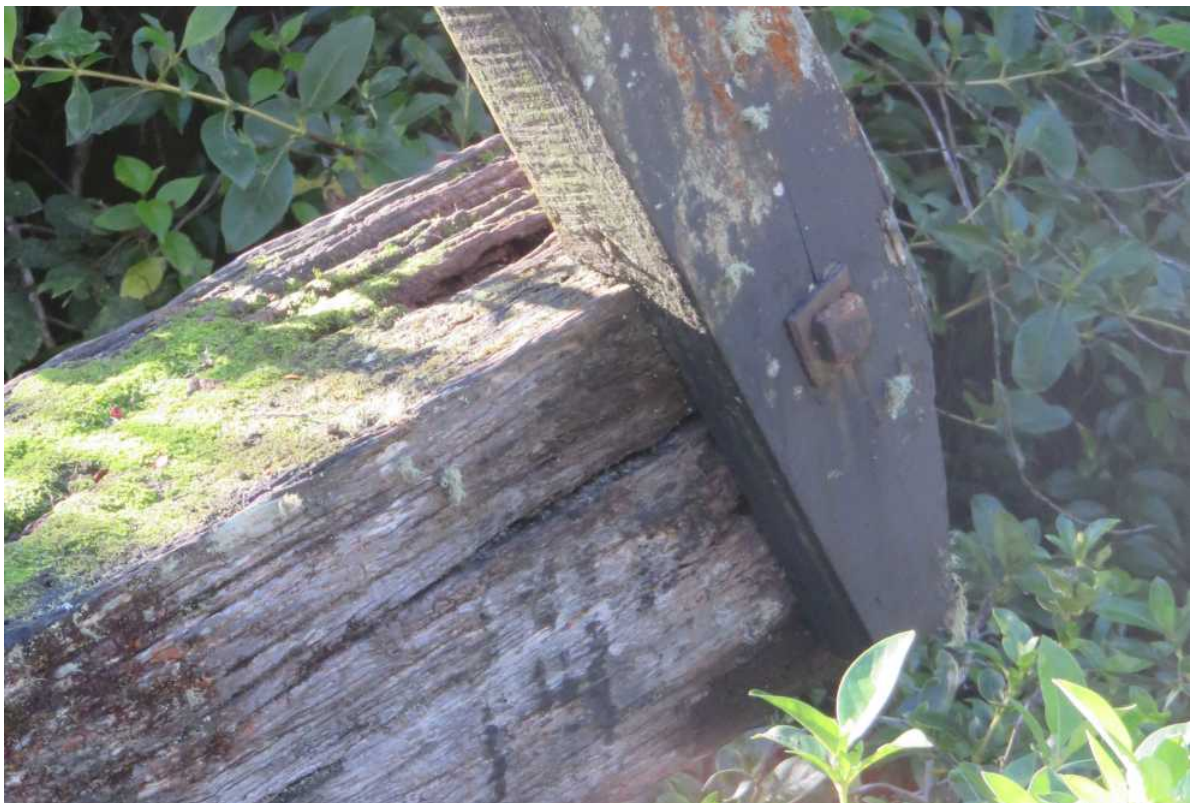
Illustration 26: Recessed butress timber secured to end of floor beam (9th June 2020).

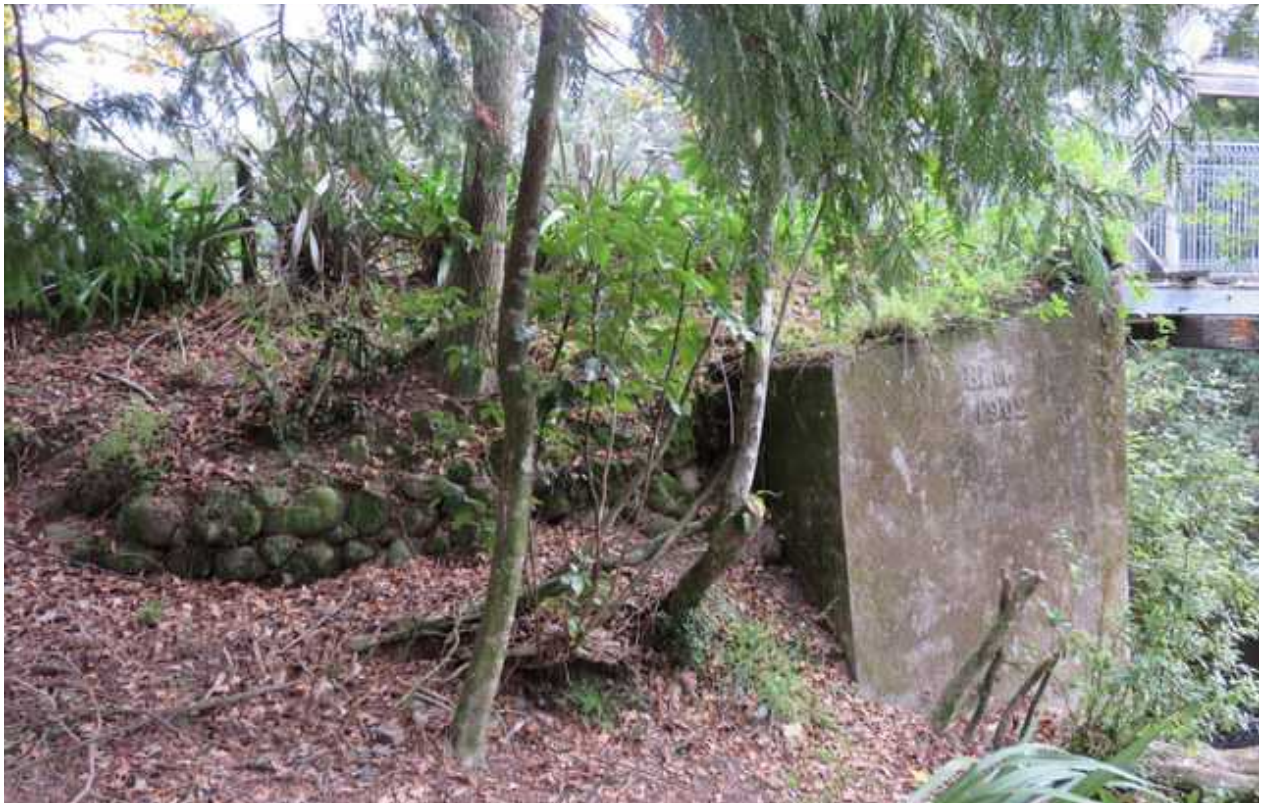
Illustration 27: Concrete abutment and stone wall at south end from rear of (22nd May 2020).

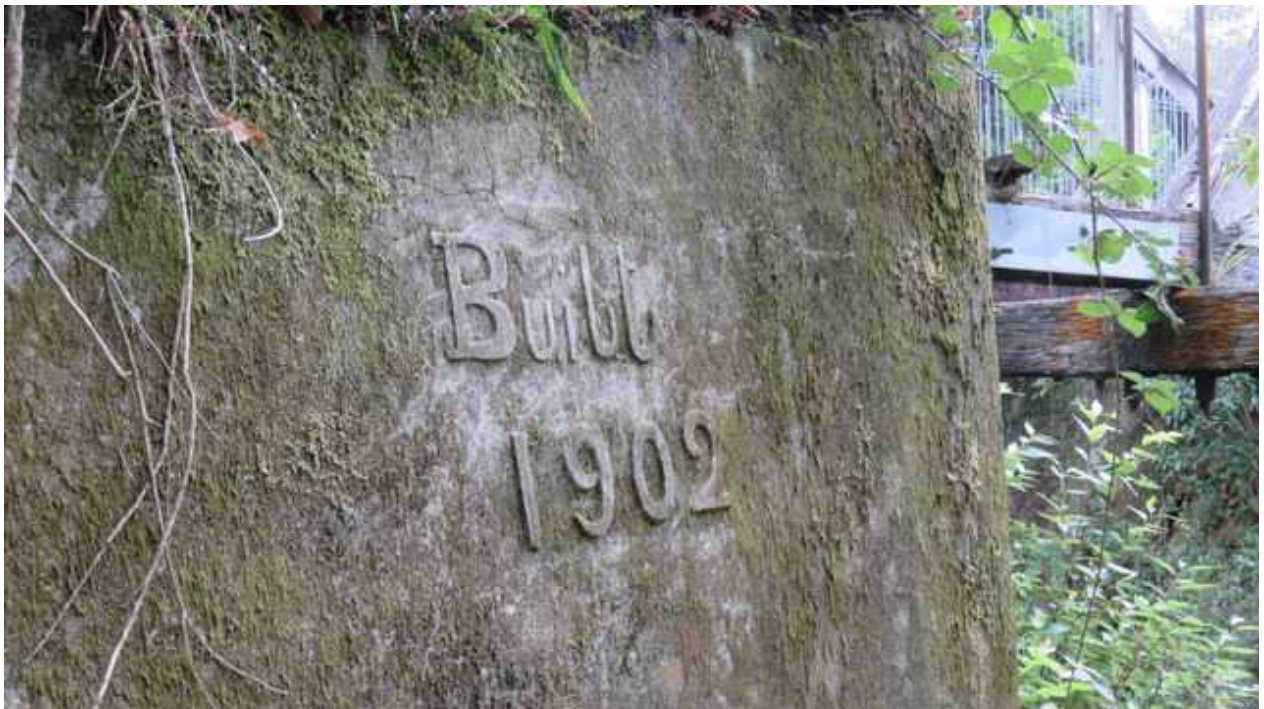
Illustration 28: Building (1902) date on concrete abutment south end (22nd May 2020).

By 1902 there were firm plans for the construction of a replacement bridge (see for instance Illustration 9). The abutments for the new bridge appear to have been cast as early as 1902, as this date is carved into the concrete on the southern end, as evidenced by subsequent clearance of encroaching vegetation (see Illustration 28).

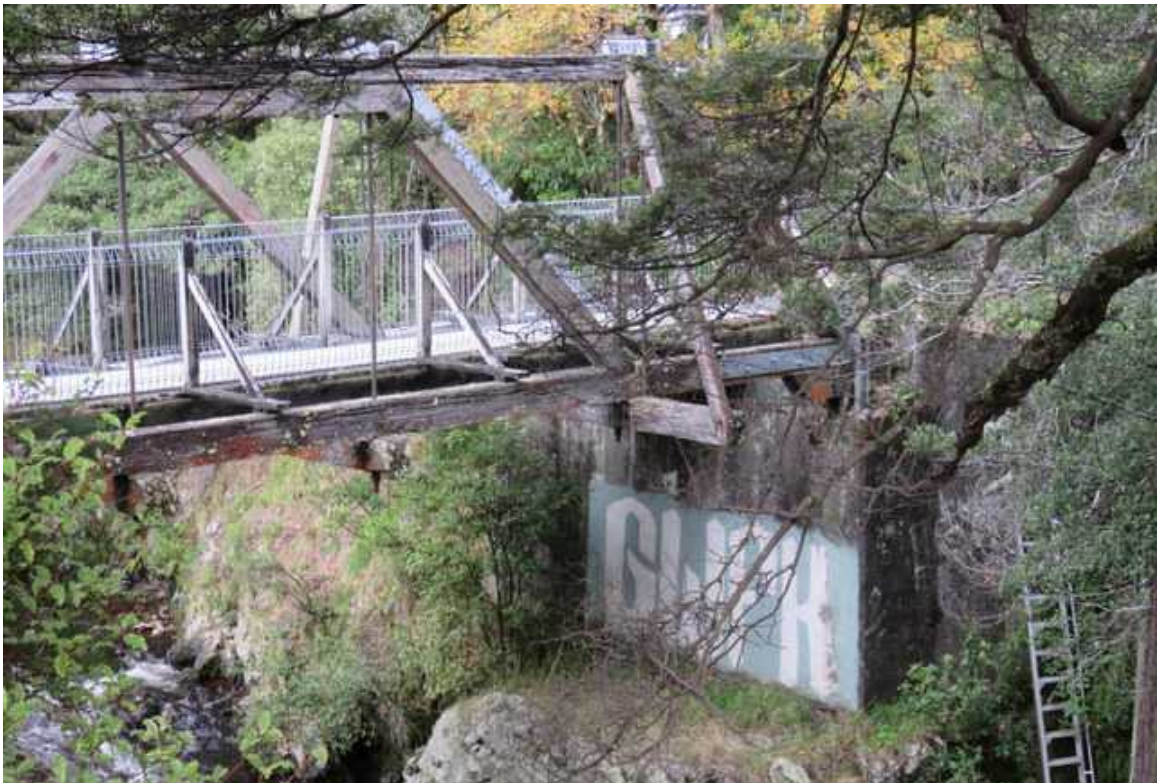
Illustration 29: Concrete abutment south end from north bank (22nd May 2020).

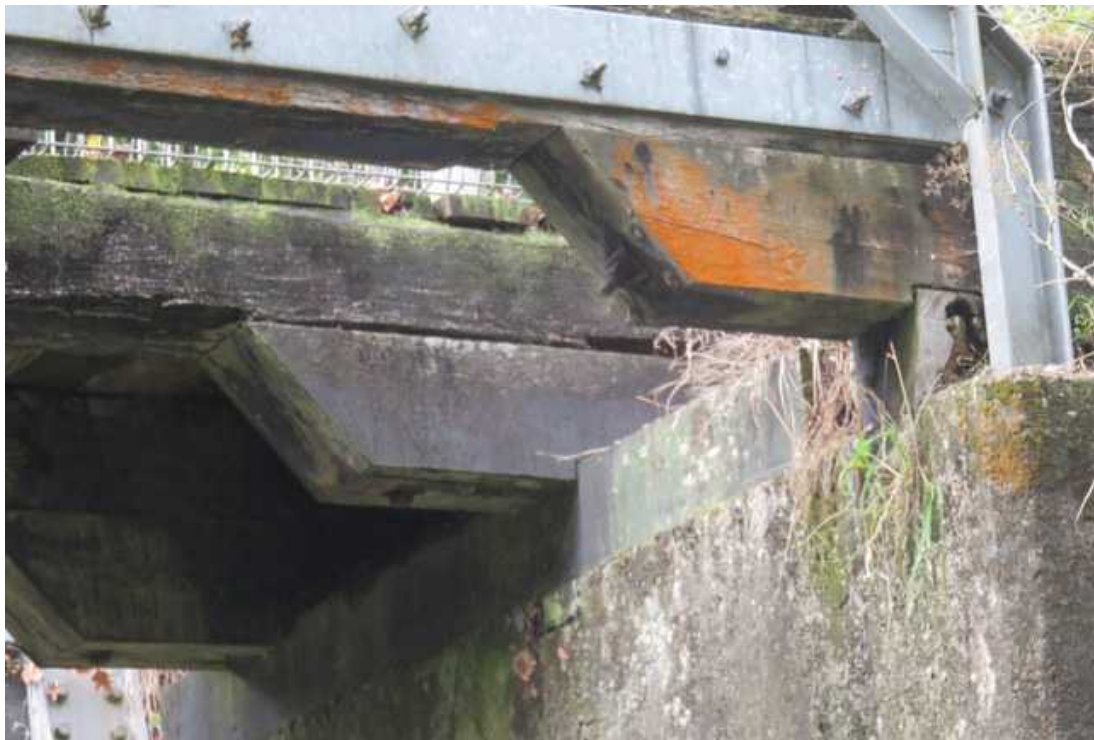
Illustration 30: Beams and stringers secured to concrete abutment at south end (22nd May 2020).

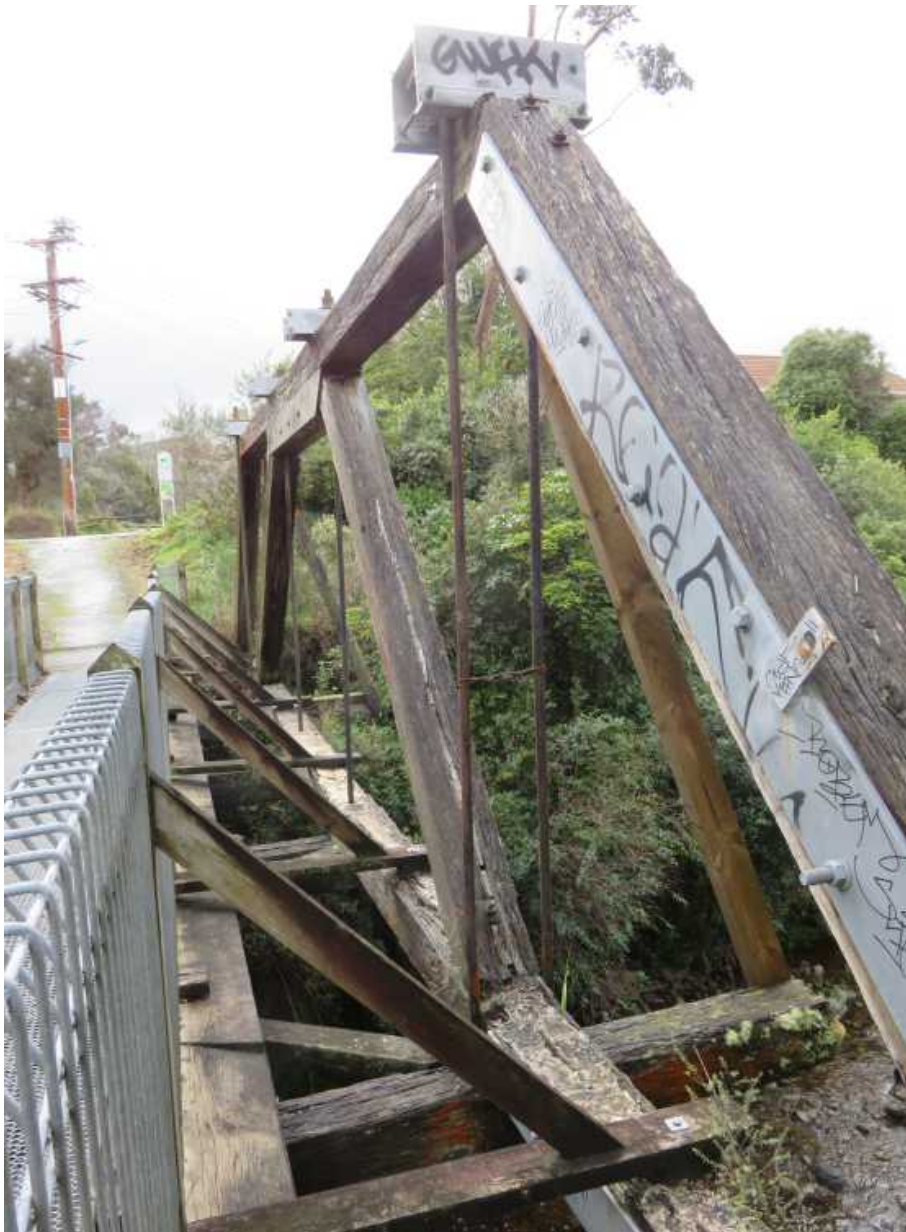
Illustration 32: Beechwood Lane bridge showing modifications to original timbers with resin filler in bottom chord, eastern side and galvanised, bolted reinforcing plates on south-eastern end post (22nd August 2019).

Several modifications were carried out by Downer in 2010. This included forcing grout into rotten areas in timbers, encasing the wooden turnbuckle hanger blocks inside metal plates and bolting on galvanised metal plates at joints of chords and floor beams in the area of the abutments. Several original hardwood timbers were also replaced with tanalised pine including the transom beam on the eastern side and the external, floor beam to top chord buttress on the south-east corner (see Illustration 32 to Illustration 34). Modifications were also made to the deck structure, with installation of a waist-high, braced and slotted, galvanised metal safety railing along the length of the stringers and non-slip metal mesh over the deck planks (see Illustration 36 and Illustration 32).

Downer carried out further modifications in 2014 with additional plugging of rotted truss and turnbuckle block timbers with epoxy resin (see Illustration 32).

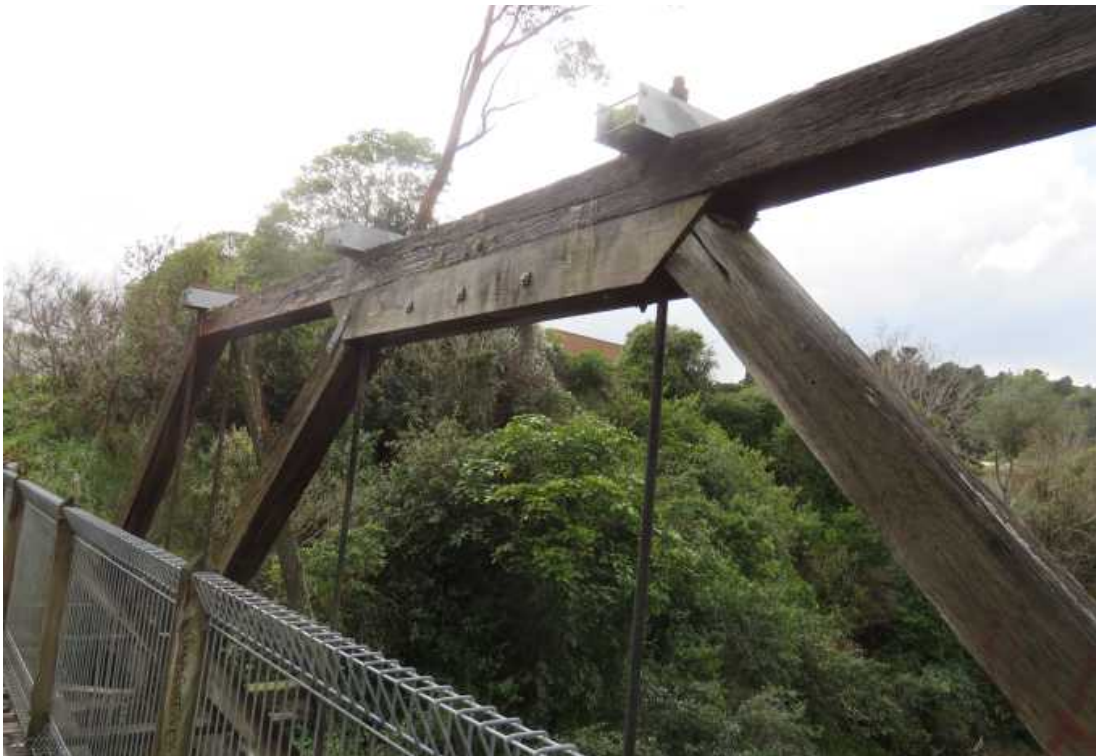
Illustration 33: Replacement pine timber transom (22nd August 2019).

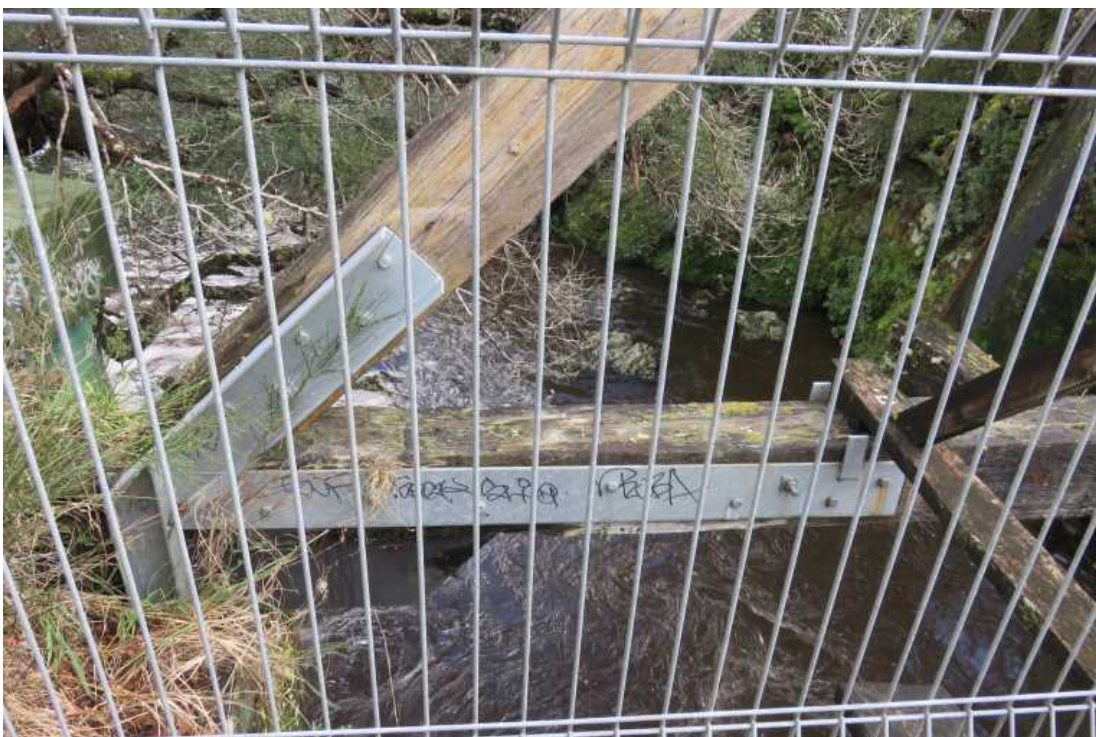
Illustration 34: Metal plates bolted to bottom chord (22nd August 2019).

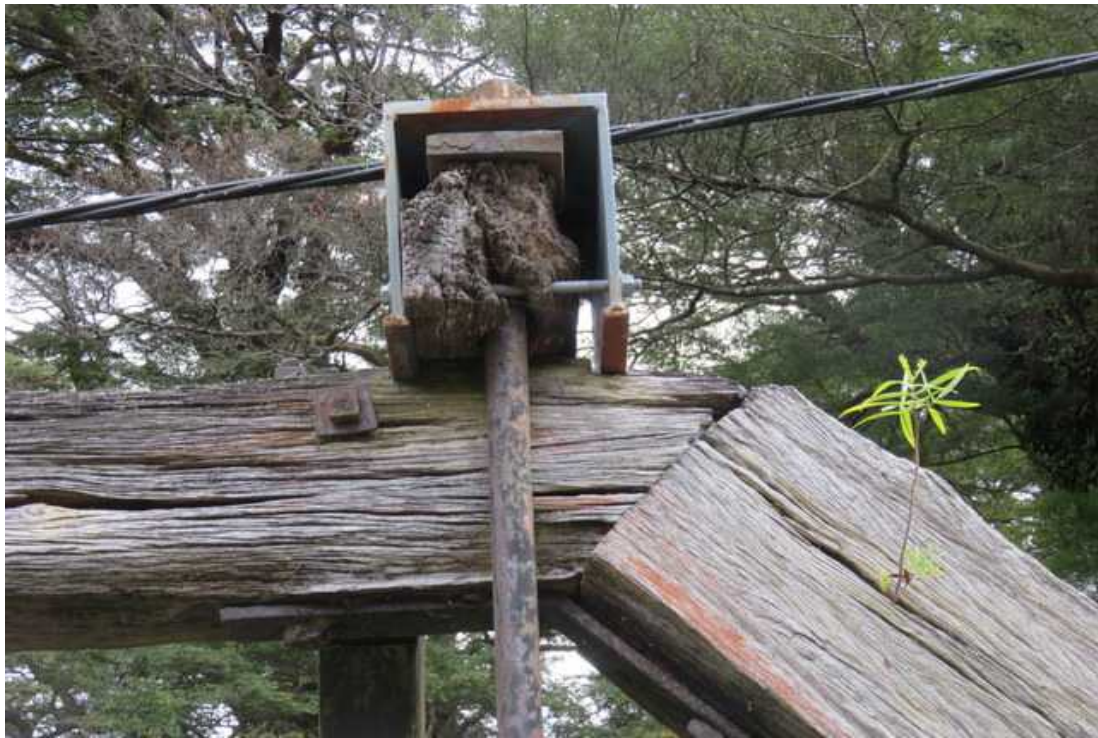
Illustration 35: Metal cap over turnbuckle timber block (9th June 2020).

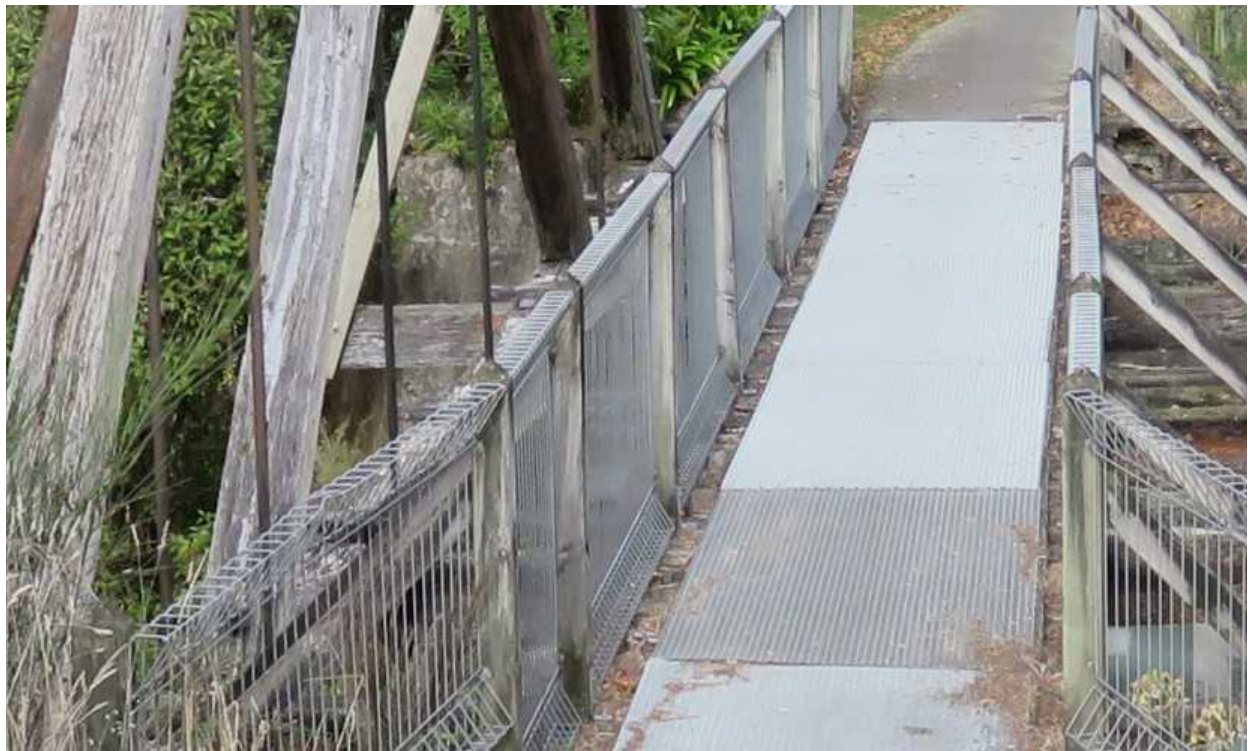
Illustration 36: Modern safety railing and deck cover (22nd May 2020).
